**University of
Northampton**

Report

**Active Quarter: Brackmills Industrial Estate 2022
- Active Travel and Physical Activity Infrastructure
For Brackmills Business Improvement District**

01/11/2022

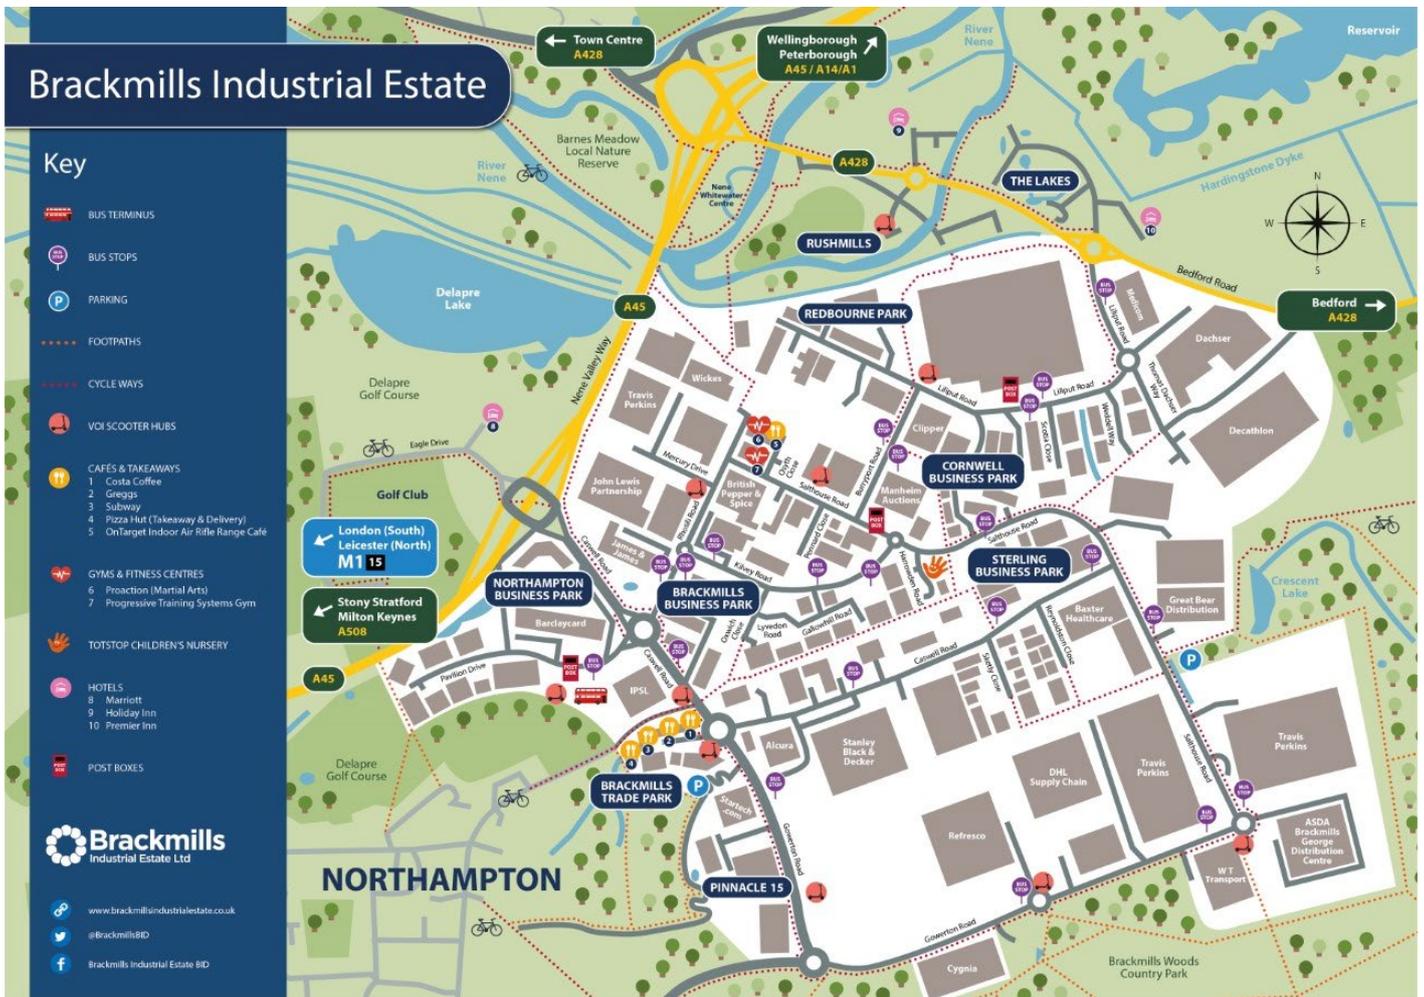
Figure 1. Footpaths (orange dotted line) and cycleways (red dotted line) within Brackmills Industrial Estate (white area) were audited for this report.

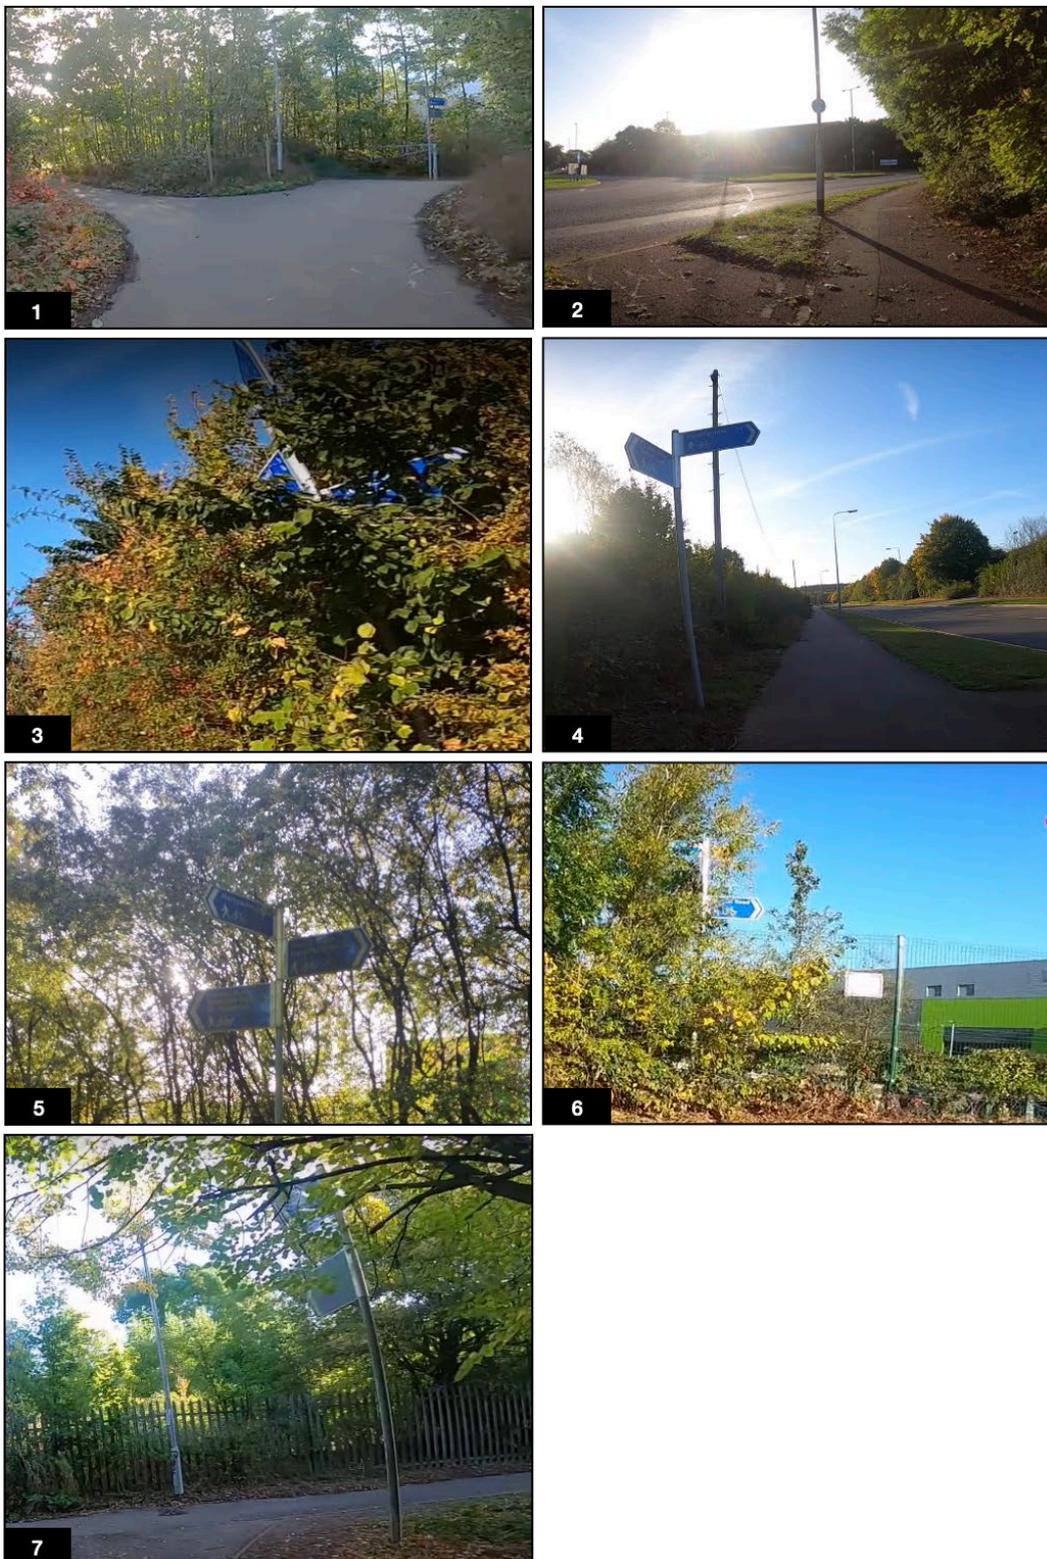
- Although there are finger posts on the right-fork of the path on the Queensbridge cycleway entrance (Image 1), there is no finger posts for the left-fork. The finger posts could be moved to the lamppost with a new left pointing finger post to direct users to Liliput Road, Brackmills Country Park, Crescent Fishing Lake, Gowerton Road, Salthouse Road, Hardingstone, and Great Houghton.

- A right finger point sign could be added to the exit point of the cycleway onto Liliput Road to direct users to Brackmills Country Park, Crescent Fishing Lake, Gowerton Road, Salthouse Road, Hardingstone, and Great Houghton (Image 2).

- The finger posts are not visible due to overgrown vegetation as users emerge from the Thomas Dachser Way cycleway (Image 3). The finger posts could be moved to an existing post on the highway, which is away from vegetation and in the line of sight of users.

- At the entrance to Brackmills Country Park on Salthouse Road, there is no finger post to direct users to Gowerton Road, even though it was listed on previous signs along the same route (Image 4). This finger post would be important for users emerging from the Sketty Close cycleway.

- The finger posts on the Salthouse Road to Sketty Close cycleway requires cleaning as the information is not legible (Image 5).
- There is overgrown vegetation blocking the finger posts on the Rhosili Road roundabout (Image 6).

- Finger posts on the slipway exit of the A45 towards Delapré Lake and Hardingstone Dyke appear to be facing the wrong way and require cleaning (Image 7).

Images 1. Queensbridge cycleway entrance (point 24). **2.** Exit onto Liliput Road (point 25). **3.** Overgrown vegetation blocking finger posts on the Salthouse Road exit from Thomas Dachser Way cycleway (point 35). **4.** Missing finger post for Gowerton Road on Salthouse Road (point 40). **5.** Dirty finger post makes it difficult to read the information, on the cycleway connecting Salthouse Road to Sketty Close (point 43). **6.** Overgrown vegetation on the Rhosili Road roundabout (point 82). **7.** Finger posts facing the wrong way on the A45 slipway exit (point 87). Click the link to locate the exact point location: <https://arcg.is/q11iL0>.

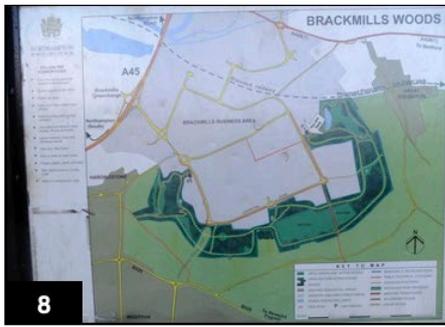
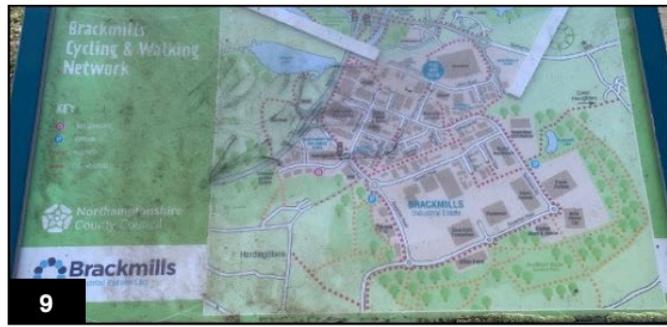
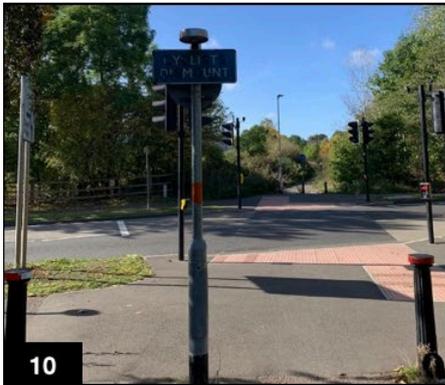
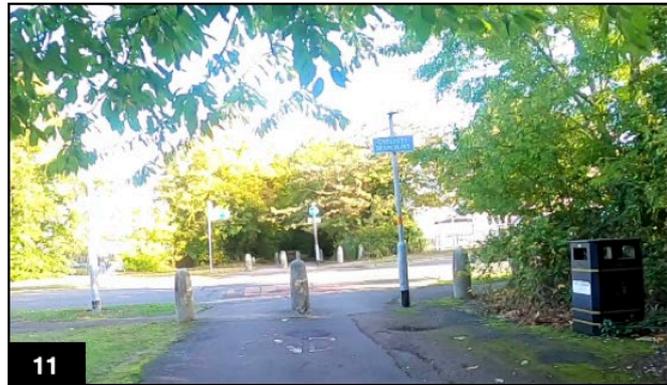
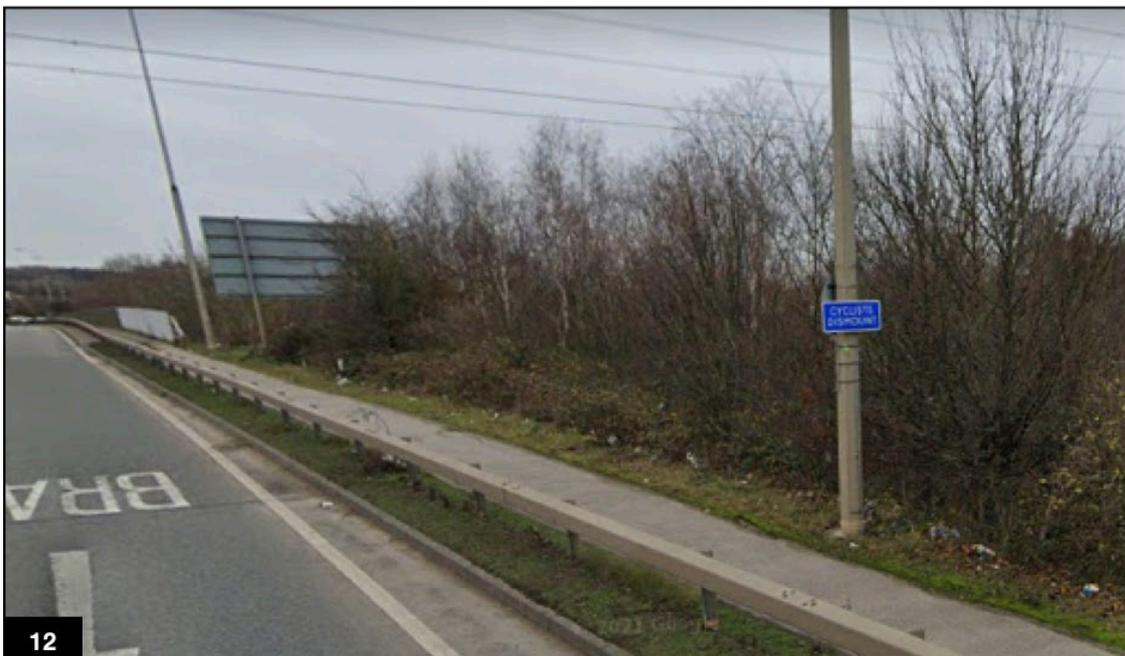
Maps are frequently placed within Information Boards on the Industrial Estate. The maps are branded with the old Northamptonshire County Council or Northampton Borough Council logos and in some cases are damaged (Images 8 and 9). Thus, the maps are due an update. It is recommended that any updates to the maps include:

There will seldom be justification for using the sign where a cycle route crosses or joins a carriageway. Therefore, it is recommended that the presence of 'Cyclist Dismount' signs are reviewed across the Industrial Estate (Images 10 – 12). For example, if the presence of Cyclist Dismount signs on the A45 are to encourage cyclists to use the routes through the river Nene, then this is causing 1.2 km (0.75 miles) diversion, whereas the direct route across the bridge between the dismount signs is 0.2 km (0.12 miles) (Image 12).

Images 8. Brackmills Woods map (point 39). **9.** Information board example (point 4). **10.** Dismount sign on the cycleway crossing on Caswell Road (point 4). **11.** Dismount sign on the cycleway crossing on Salthouse Road (point 20). **12.** Dismount sign on the shared path along the A45 (point 86). Click the link to locate the exact point location: <https://arcg.is/q11iL0>.

- Orientation of the map in the same direction as the viewer is facing;
- Street names on the map;
- Sketches/photos of significant buildings and other landmarks;
- Isochrones showing typical walk/cycle times;
- Align with information that is provided on finger point signs;
- 'You are here' location markers.

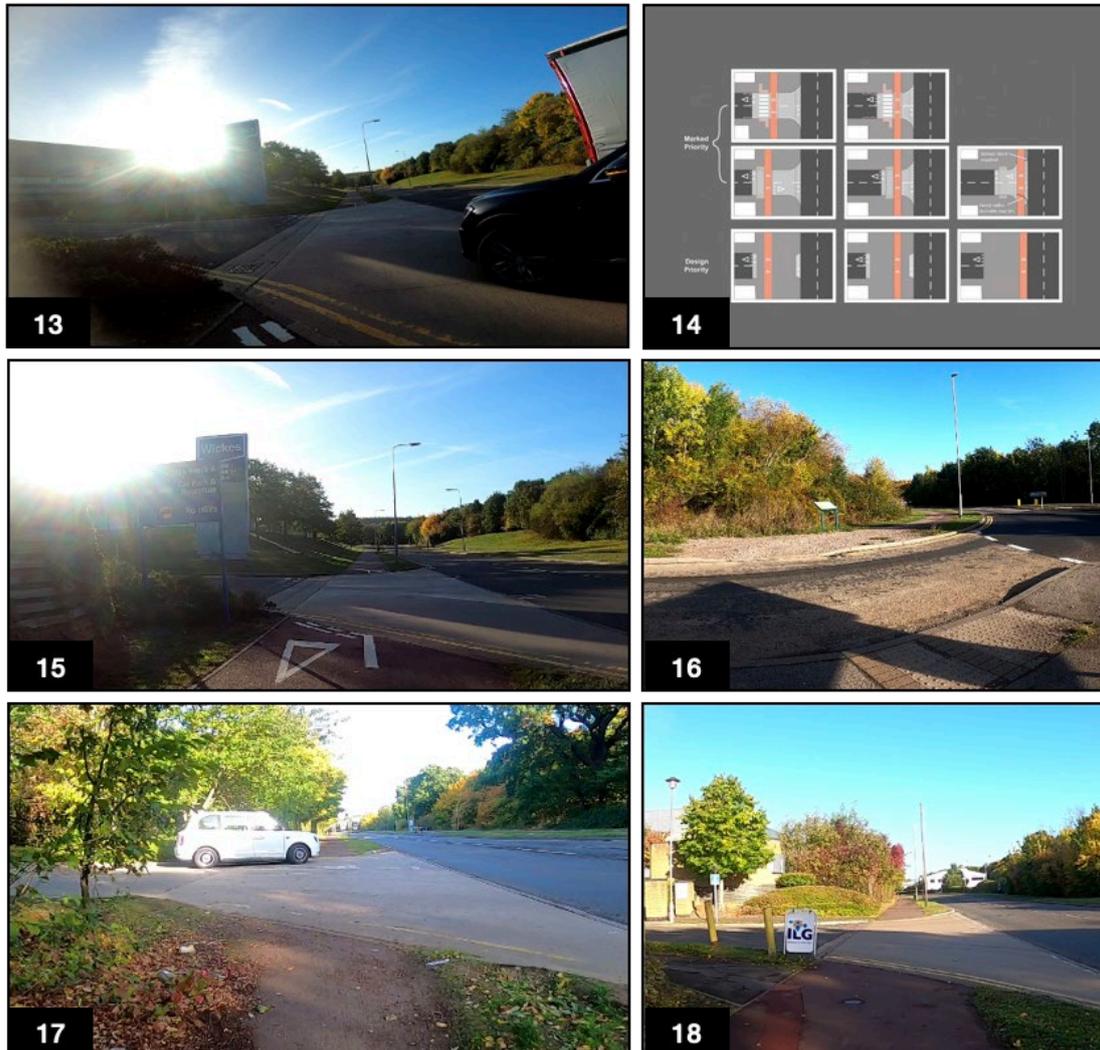
The images provide illustrative examples of missing blister surfaces at uncontrolled crossings along the footpaths and cycleways within the Industrial Estate (Images 15 – 18). Image 16 identifies a missing

footpath in its entirety at a roundabout crossing point on the corner of Landimore Road – Gowerton Road. The omission of the footpath appears to be a recent change as there was a complete footpath at this junction as late as March 2021 (according to Google Street View).

Images 13. Salthouse Road sideroad crossing (point 38). **14.** Figure 10.13 from LTN 1/20. **15.** Salthouse Road sideroad crossing (point 38). **16.** Missing footpath on Landimore Road (point 74). **17.** Gowerton Road sideroad crossing (point 75). **18.** Gowerton Road sideroad crossing – second example (point 75). Click the link to locate the exact point location: <https://arcg.is/q11iL0>.

It is recommended that the BID review the junctions in the Industrial Estate to determine whether amendments are required to protect the most vulnerable road users. For example, there are junctions indicating that pedestrians and cyclists should Give Way at the junction (Image 13), which means they currently lose priority. Even though these junctions clearly state who has priority, the junctions do not align with LTN 1/20 and are also not consistently implemented across the Industrial Estate. [Section 10.5 of LTN 1/20](#) provides guidance to create vulnerable road user priority junctions (Image 14).

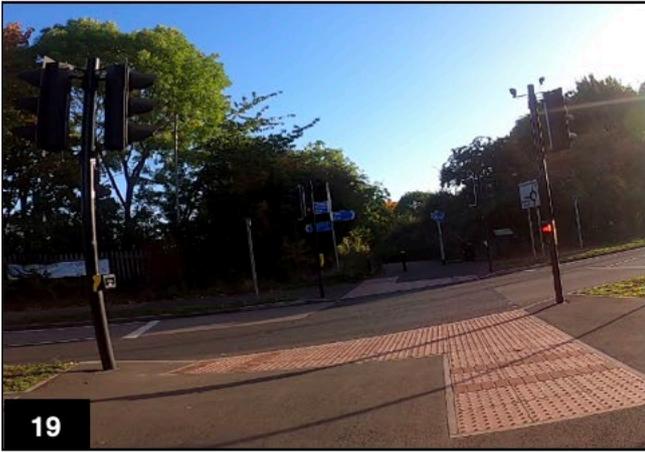
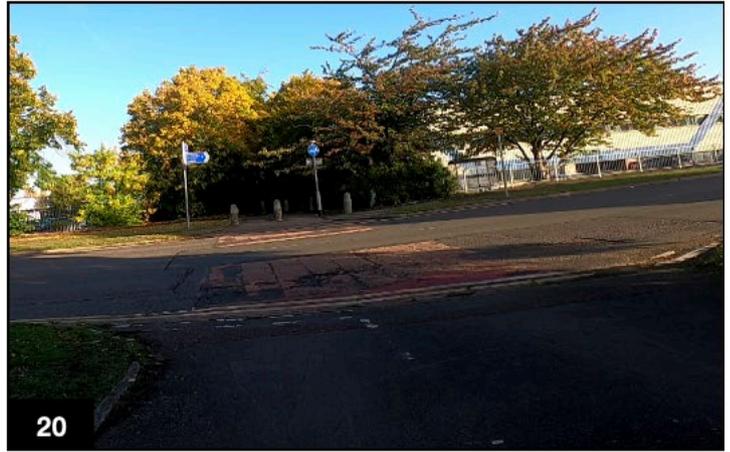
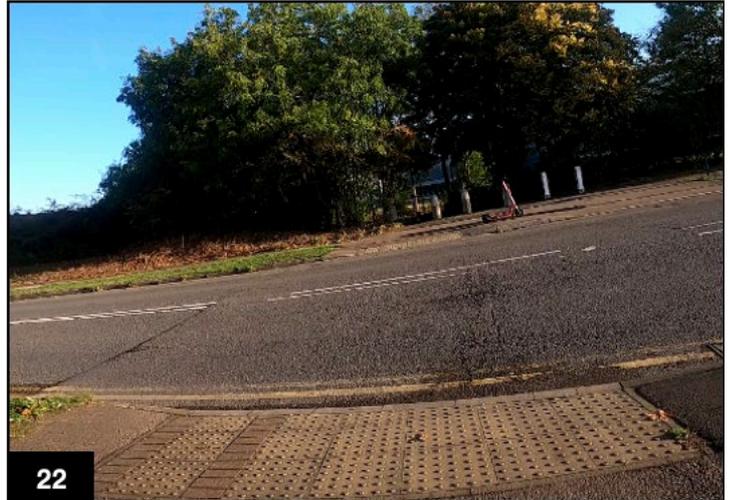
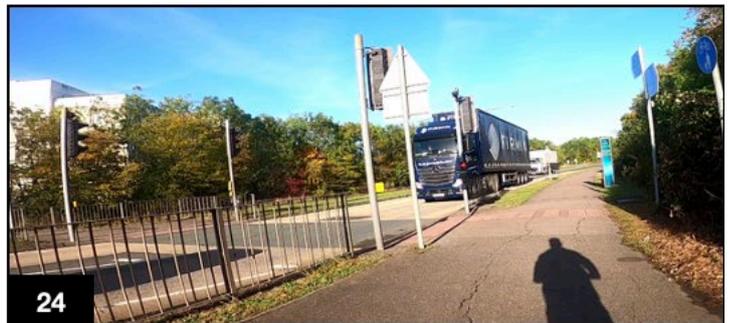
- two provide the recommended toucan crossing for the road type (Images 19 and 24),
- three provide a drop kerb with blister surfacing (Images 21, 22, and 28), and
- five provide no blister surfacing (Images 20, 23, 25, 26, and 27).

Images 19. Toucan crossing on Caswell Road (point 4). **20.** Missing crossing and blister surface on Salthouse Road (point 20). **21.** Missing crossing on Burryport Road (point 21). **22.** Missing crossing on Liliput Road (point 23). **23.** Missing crossing and blister surface on Salthouse Road (point 40). **24.** Toucan crossing on Caswell Road (point 83). Click the link to locate the exact point location: <https://arcg.is/q11iL0>.

It is recommended that the eight other crossing points within the Industrial Estate are reviewed in line with LTN 1/20 guidance to determine the need for crossing infrastructure to make the provision suitable for most people.

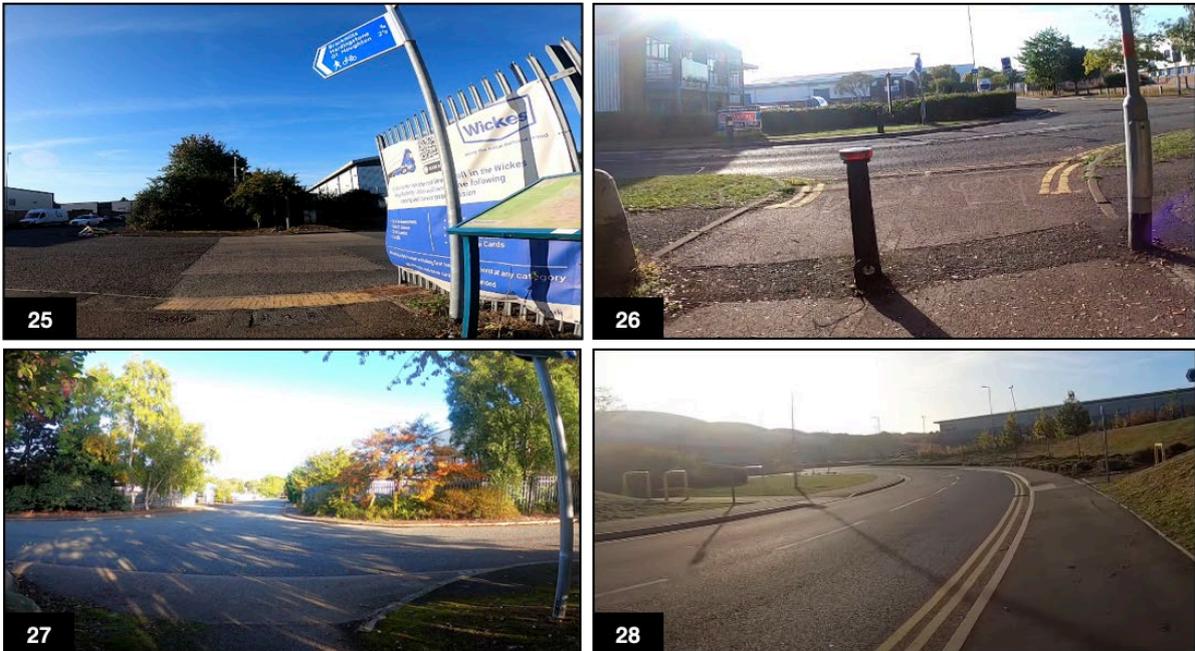
Images 25. No pedestrian crossing at the end of the footpath/cycleway on Rhosili Road (point 89). **26.** No pedestrian crossing or drop kerb to access Sketty Close from the Caswell Road exit (point 46). **27.** No pedestrian crossing or drop kerb to access Sketty Close from the Salthouse Road shared path (point 44). **28.** Missing crossing on Thomas Dachser Way (point 33). Click the link to locate the exact point location: <https://arcg.is/q11iL0>.

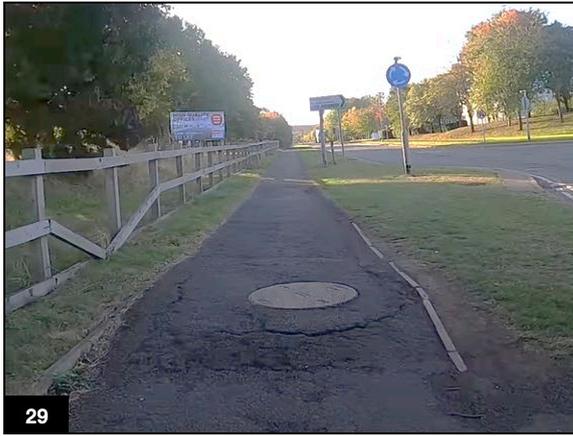
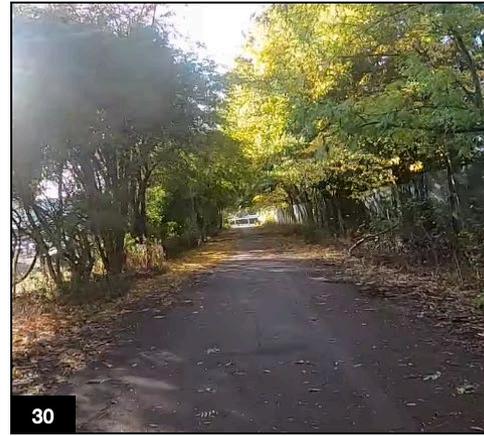
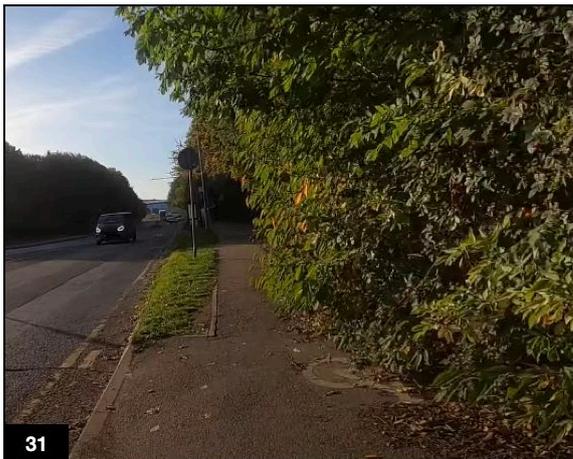
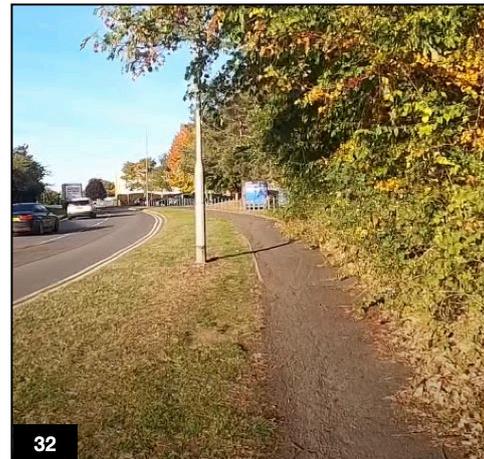
The report captured videos of the pavement conditions on the footpaths and cycleways that were audited (Image 29), which can be reviewed in the future planning of the Industrial Estate. Much of the route was shared use paths between pedestrians and cyclists. These paths are suitable where pedestrian traffic is low.

[Department for Transport LTN 1/20](#) recommends a minimum width of 3.0 metres for shared use paths (Image 30). Future planning may investigate the feasibility of increasing the provision of cycleways throughout the Industrial Estate so high-quality infrastructure reaches each business on the estate. LTN 1/20 states that the conversion of existing footways to shared use should only be considered when options that reuse carriageway or other (e.g., verge) space have been rejected as unworkable. There are instances where vegetation is encroaching on footpaths, and it is recommended that regular trimming and verging of vegetation is conducted to maintain shared use path width (Images 31 and 32).

Images 29. Sunken footpath on Salthouse Road (point 37). **30.** Example of shared use path over 3.0 metres wide (point 6). **31.** Example of encroaching vegetation on Liliput Road (point 26). **32.** Salthouse Road shared use path under 3.0 metres wide and encroached by vegetation (point 35). Click the link to locate the exact point location: <https://arcg.is/q11iL0>.

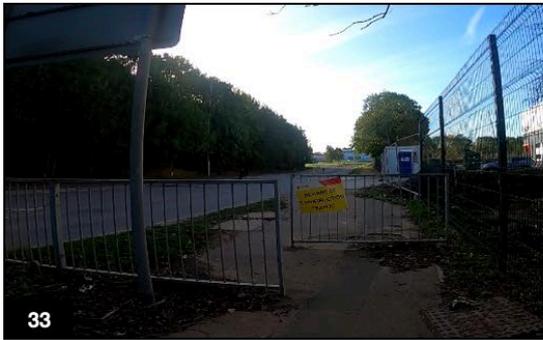
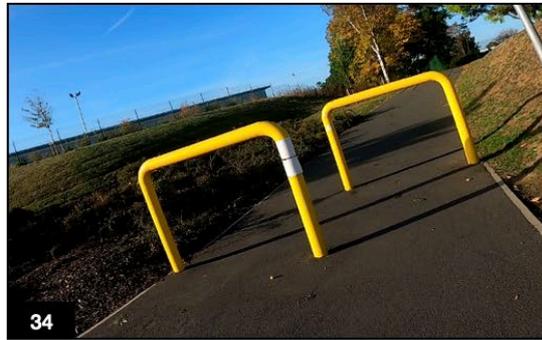
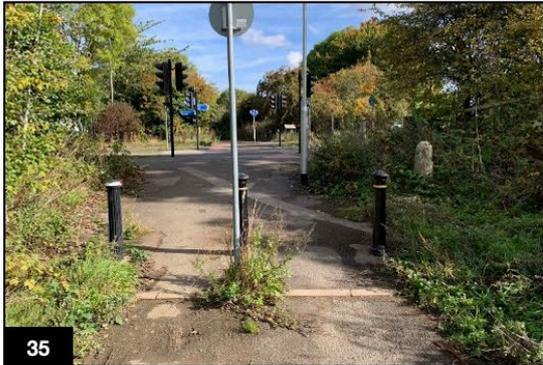
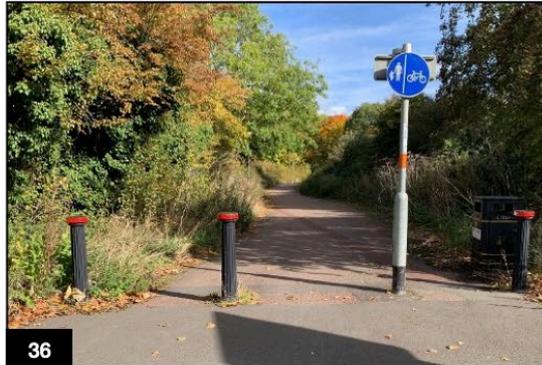
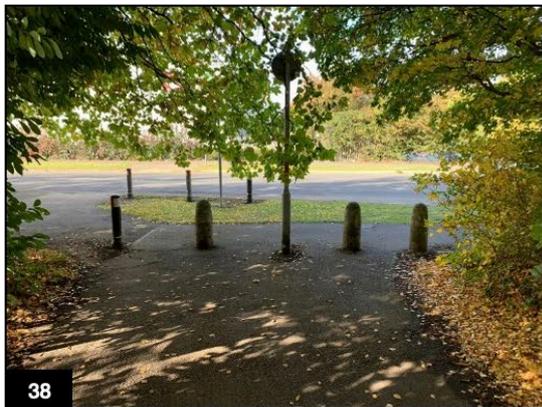
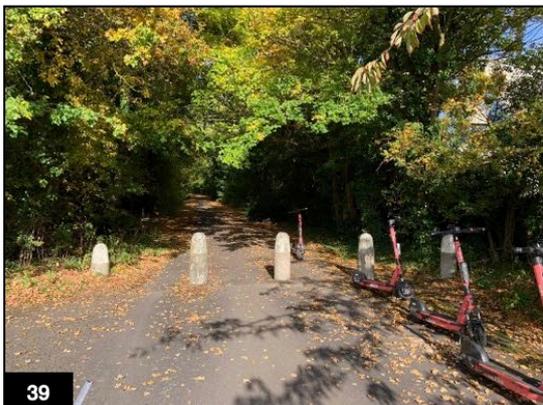
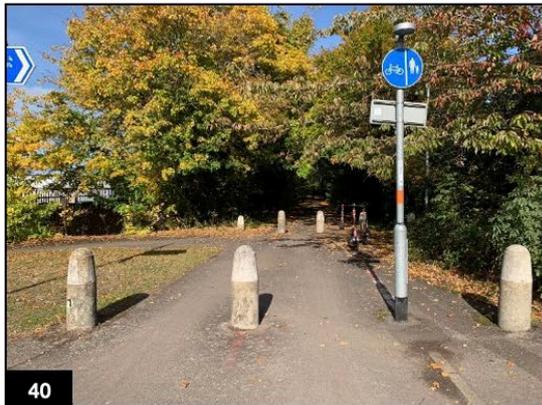
Chicane barriers cannot be used by people on tandems, tricycles, cargo bikes, adapted bicycles and people with child trailers. They may also be inaccessible to some types of wheelchair and mobility scooters. An access control that requires cyclists to dismount will exclude hand cyclists and others who cannot easily walk.

An alternative method is to provide bollards at a minimum of 1.5 metre spacing, which allows users to approach in a straight line whilst permitting all types of cycle and mobility scooters to gain access. If access is required by wider maintenance vehicles, a lockable bollard can be used. Bollards and barriers should contrast with the background and may be fitted with retroreflective material to ensure they can easily be seen in all conditions. Images 33 - 44 identify chicanes or bollards that do not conform to these [LTN 1/20 standards](#).

Images 33. Chicane on Liliput Road (point 27). **34.** Chicane on Thomas Dachser Way (point 33). **35.** Houghton Hill – Caswell Road bollards do not meet standard (point 4). **36.** Caswell Road – middle gap meets standard (point 4). **37.** Liliput Road do not meet standard (point 23). **38.** Burryport Road do not meet standard (point 21). **39.** Salthouse Road to Burryport Road left gap meets standard (point 20). **40.** Salthouse Road to Burryport Road does not meet standard (point 20). Click the link to locate the exact point location: <https://arcg.is/q11iL0>.

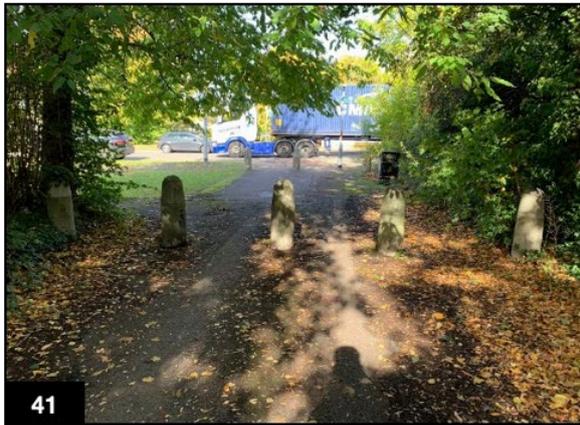
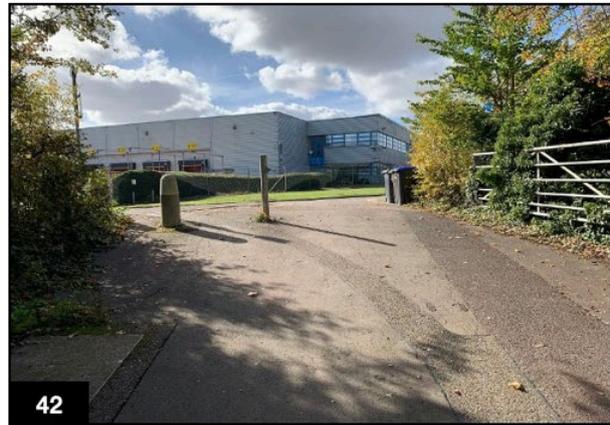
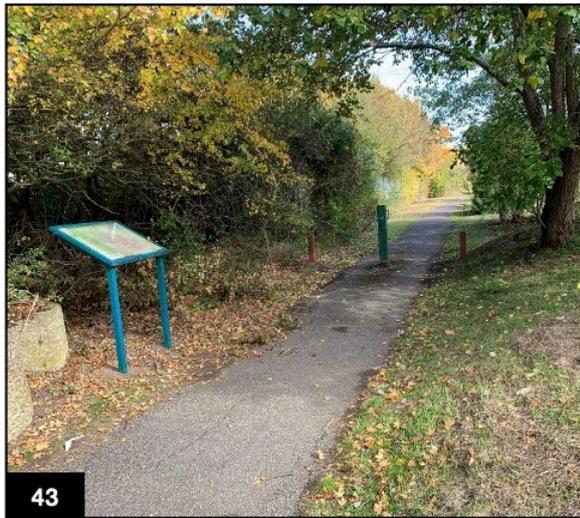
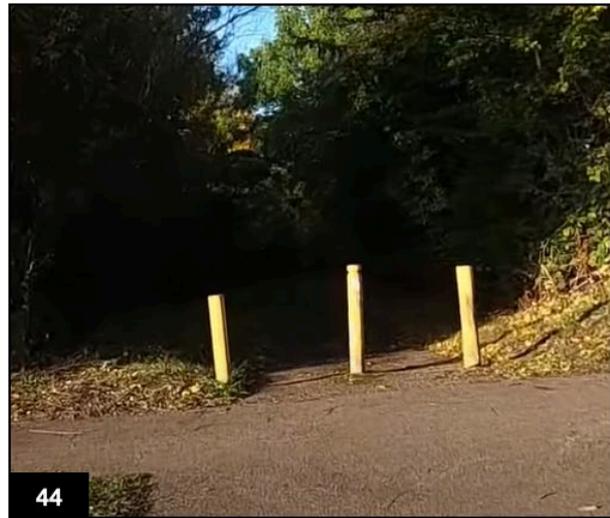
Images 41. Caswell Road to Salthouse Road does not meet standard (point 20). **42.** Thomas Dachser Way to Salthouse Road does not meet standard if the gate is shut (point 35). **43.** Brackmills Country Park entrance does not meet standard (point 39). **44.** Salthouse Road to Sketty Close does not meet standard (point 41). Click the link to locate the exact point location: <https://arcg.is/q11iL0>.
